Monitoring Data Record

Project Title: I-540 Northern Wake Expressway (R-2000AB) COE Action ID: 200021863

Stream Name: UT to Kit Creek DWQ Number: 030918

City, County and other Location Information: Wake County, Site 6 (Sta.10+41 to 12+76 YRPA-)

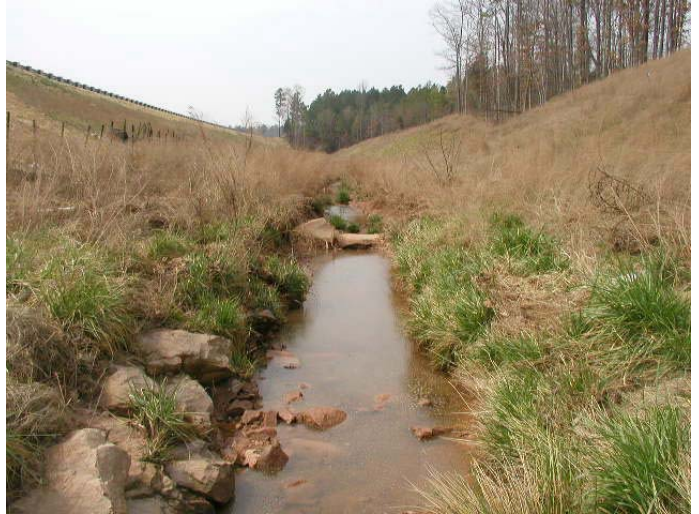
Photo Point #1 (Downstream)

The stream is mostly stabilized for the second year of monitoring. There is some bank erosion on the left bank at the inlet of the box culvert located at approx. Sta. 12+70 (Photo Point #5 Downstream). The left arm of the 2nd crossvane from the start of the relocation at approx. Sta. 10+50 has eroded (Photo Point #1 Downstream).

According to emails between the regulatory agencies and DOT here are the following solutions to these problem areas. The left bank at the inlet of the box culvert will be lined with rip rap. The failed cross vane at approx. Sta. 10+50 will be removed from the channel. The triassic rock located along the channel would make it impossible to re-stabilize this cross vane. The removal of this cross vane should not result in degradation of the relocated channel. There was evidence that a bankfull event had occurred at this stream relocation.
